REHABILITATION OF EXISTING
CONCRETE PAVEMENT WITH
HOT PLANT MIX ON I-80

- DANA RIDGE, PROJECT # 0804236, WALCOTT JCT. - LARAMIE
- LOCATED ON INTERSTATE 80 FROM R.M. 240 TO R.M. 246 IN EAST BOUND LANE IN WYOMING.
- EASTBOUND DIRECTION CONSISTING OF 3 CLIMBING LANES OF CONCRETE.
- 11 INCHES CONCRETE PAVEMENT (DOWELED) OVER 10 INCHES OF CRUSHED BASE.

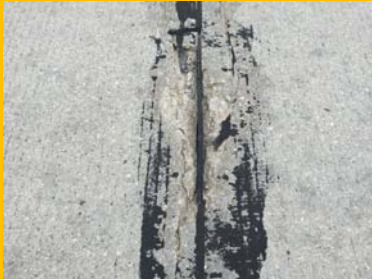
ACR CAUSED THE CONCRETE JOINTS TO EXPLODE!

ACR DAMAGED JOINTS

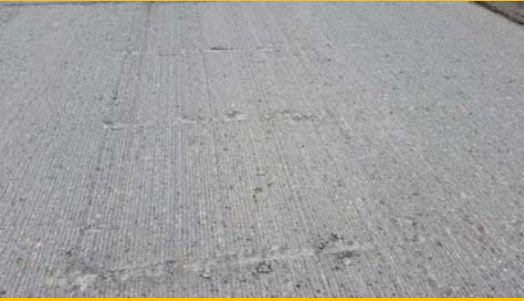
3" MILLING CONCRETE PAVEMENT

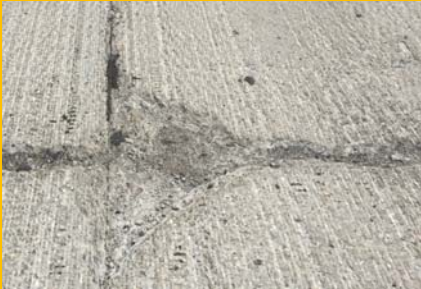
3" MILLING CONCRETE PAVEMENT: DID NOT REMOVE ALL DETERIORATION AFTER MILLING.

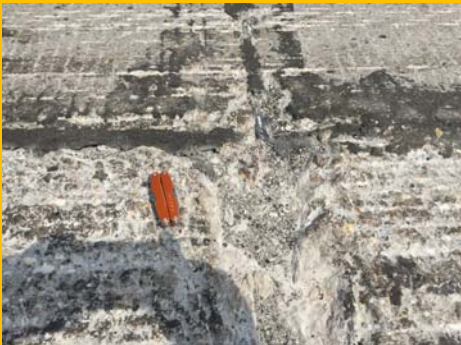
3" MILLING CONCRETE PAVEMENT

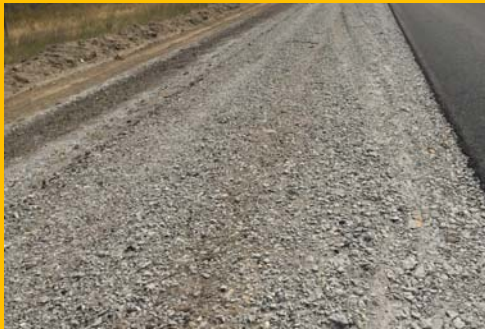
CONSTRUCT SHOULDERS

COMPACTED CONCRETE MILL TAILINGS

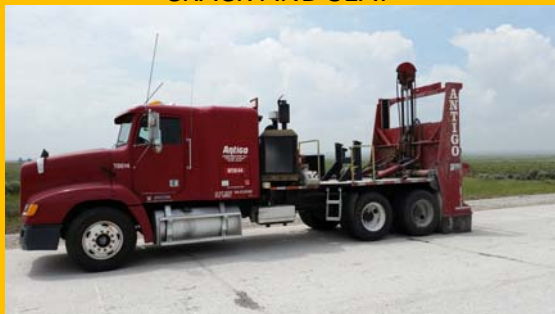
CRACK AND SEAT

•CRACK AND SEAT THE MILLED SURFACE OF THE CONCRETE TO LIMIT REFLECTIVE CRACKING

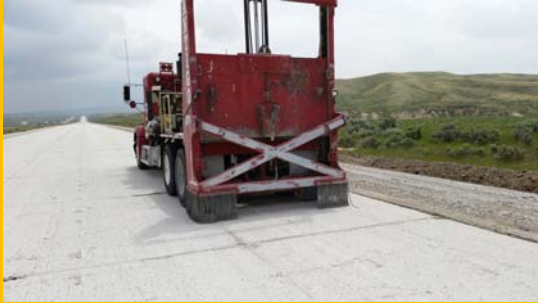
CRACK AND SEAT

•CRACK AND SEAT THE MILLED SURFACE OF THE CONCRETE TO LIMIT REFLECTIVE CRACKING

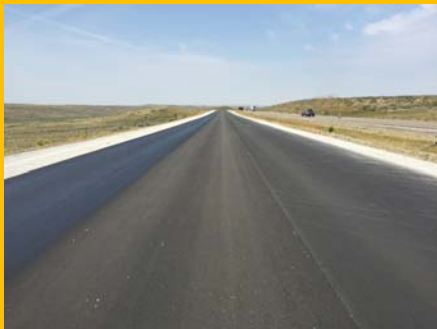
HOT PLANT MIX

1. APPLIED AN INITIAL LIFT OF 1" OF LEVELING HPM

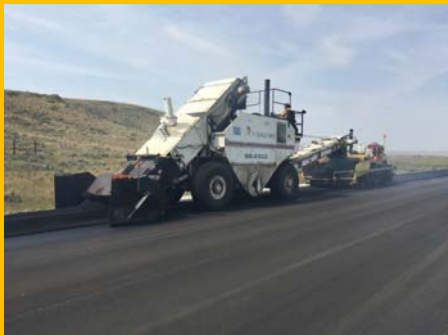
2. APPLIED A 4" LIFT OF HOT PLANT MIX
