### SHOULDER & INTERSECTION WIDENING

### FDR

### PAVING

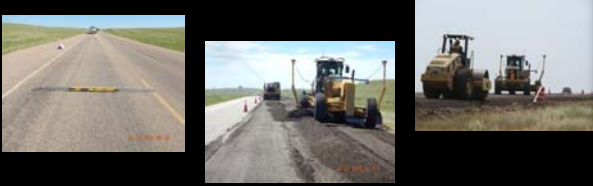
- Excess material was picked up and stockpiled with a scraper
- Double checked the grade with a straight edge
